## The City's Water Distribution System

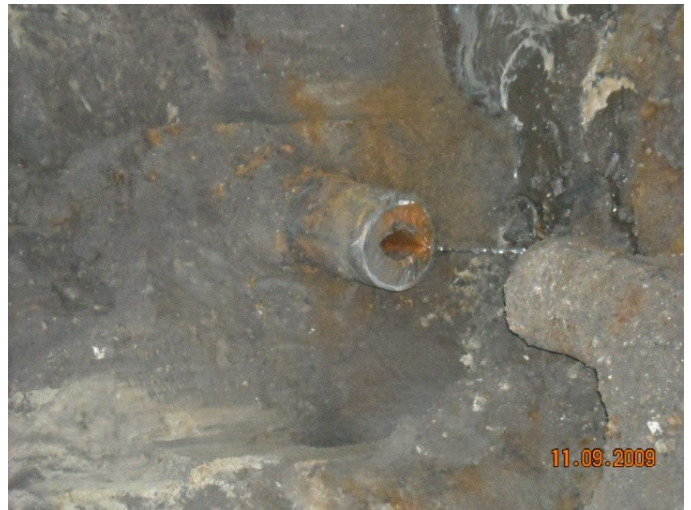
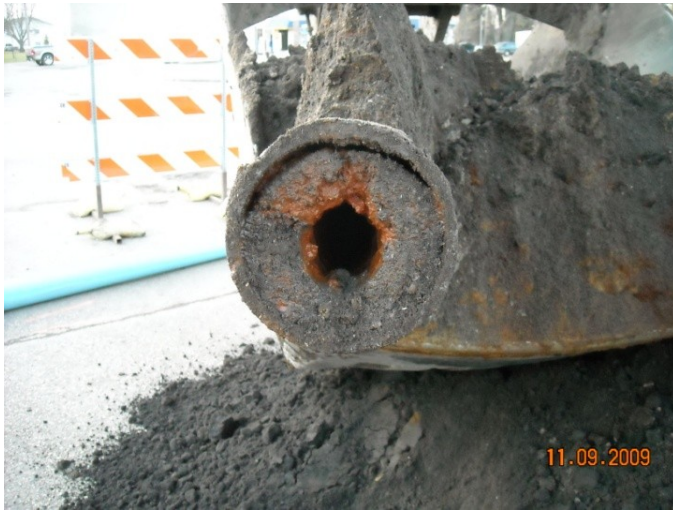
These photos taken during the past 2 months of construction are an example of the condition of the existing water mains here in Oakes. The photo shows a section of cast iron pipe (CIP) water main that has been in service in the City for over 60 years. As shown on the photo, the water main has a thick layer of iron-rich scale that has built up on the interior of the pipe over the years. This scaling has a reddish color which builds and builds to a point where water flow can be severely restricted. In this case, more than  $\frac{1}{2}$  of the pipe is blocked. This explains the reddish color you may see from your tap from time to time. For example, whenever there is a large need for water, such as during a fire, the high flow of water through the mains agitates the system and pieces of the red scaling breaks off into the water. See the diagram below for an illustration of this scenario.

The City of Oakes is continuously working to replace deteriorated infrastructure throughout the City. One of the major goals of the construction project currently being completed in the City is to remove the cast-iron water mains and replace them with new PVC water mains. By replacing the corroded water mains, the water quality and water flow will be greatly improved throughout the City.
